Continuous GSM interference from intermodulation

IDA 2 can determine the causes

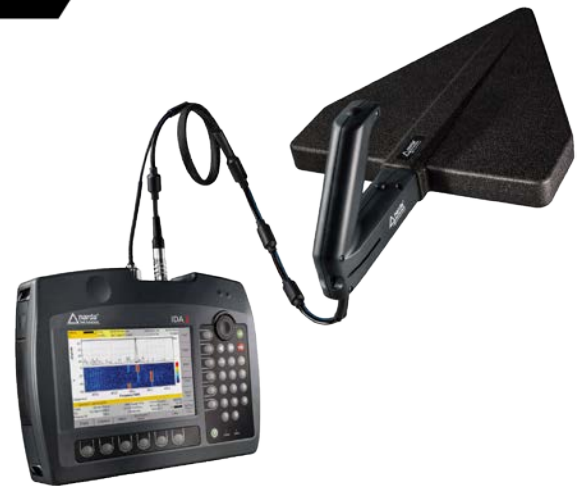
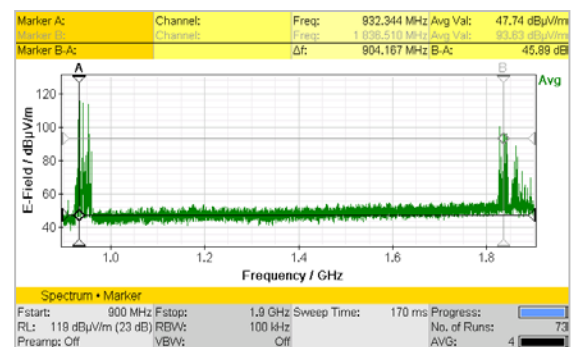
Figure 1: Overview of the GSM 900 and GSM 1800 frequency range. The differences between the many frequencies shown in the spectrum could fall within the GSM 900 uplink range. Example (markers A and B): 1836 MHz downlink – 932 MHz downlink = 904 MHz uplink. The field strengths of over 100 dBµV/m are also enough to produce intermodulation in non-linear structures.

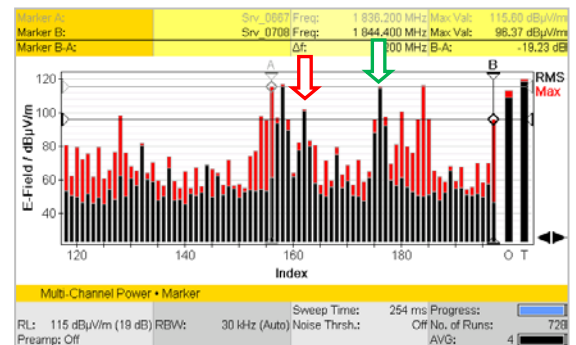
Figure 2 shows channels in the GSM 1800 band. The channel with index number 176 (green arrow), for example, has a high, virtually constant level, which makes it easily identifiable as a control channel (BCCH). The BCCHs can be suspected in each case as being the source of any continuous impairment. The list view shown in figure 3, arranged in order of maximum field strengths, shows this channel in fifth place. A total of six channels cause field strengths in excess of 100 dB μ V/m.

Figure 2: Multi-Channel Power measurement in the GSM 1800 downlink band, bar graph view. Control and traffic channels (BCCH and TCH) are clearly distinguishable by the difference between the RMS and MAX values.

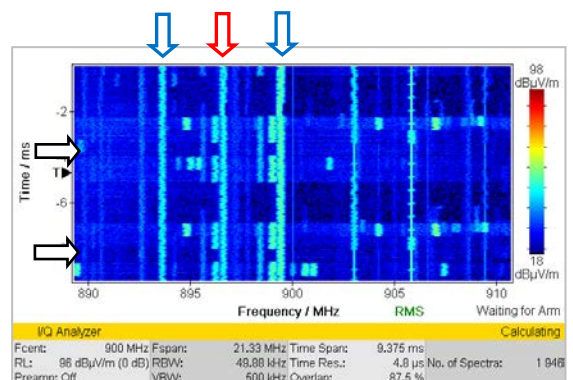
The spectrogram depicted in figure 5 shows some continuous signals in the GSM 900 uplink band that are of approximately equal strength, which are normally not present in the uplink direction (blue / red arrows). The frequencies match the intermodulation table. The typical horizontal bars of uncontrolled frequency conversion are also visible (black arrows). These frequency conversion products only occur, of course, when both the TX channels causing them are "on air".

Figure 5: Spectrogram. Section of the GSM 900 uplink band. The strong constant signals are atypical for the uplink direction.

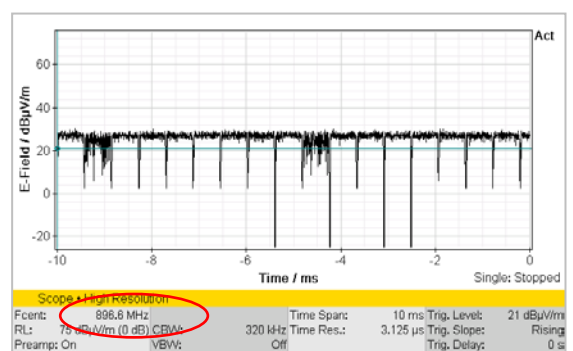
The time domain measurement shown in figure 6 confirms the GSM structure. The duration and repetition of the timeslots is within the GSM standard: In each case, seven timeslots are occupied by telephony (GMSK modulation, constant level), and the eighth timeslot is used for EDGE (8PSK modulation, variable level). Typical for a BCCH: All timeslots are continuously occupied and have the same maximum level. A BCCH in the GSM downlink is thus proven to be the source of interference.

Figure 6: The time characteristic of the signal at 896.6 MHz shows the typical structure of a GSM downlink BCCH with its timeslots. All slots are occupied; one is filled with a dithering EDGE signal.

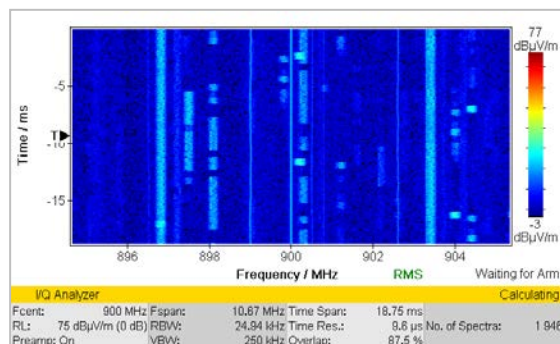
Figure 7: Example of a spectrogram with (artificially generated) intermodulation.

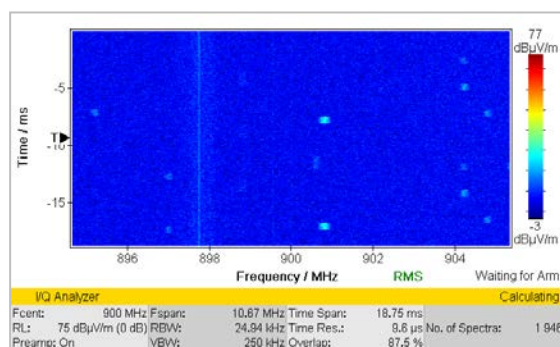
Figure 8: As above but without intermodulation.
