# Continuous GSM interference from intermodulation

## IDA 2 can determine the causes

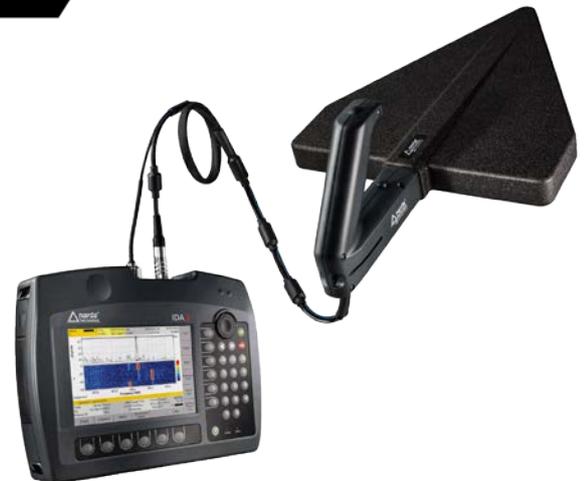
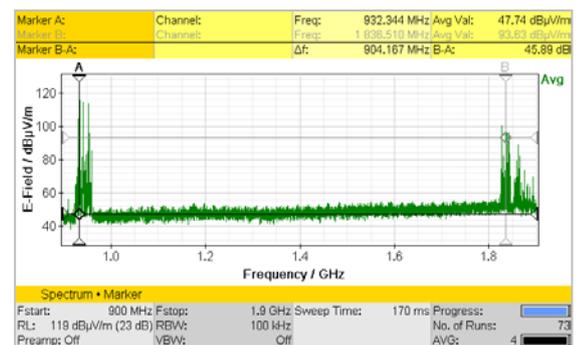
**Figure 1: Overview of the GSM 900 and GSM 1800 frequency range. The differences between the many frequencies shown in the spectrum could fall within the GSM 900 uplink range. Example (markers A and B): 1836 MHz downlink – 932 MHz downlink = 904 MHz uplink. The field strengths of over 100 dBµV/m are also enough to produce intermodulation in non-linear structures.**

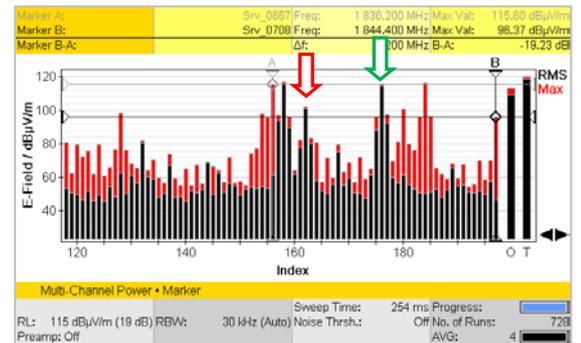
Figure 2 shows channels in the GSM 1800 band. The channel with index number 176 (green arrow), for example, has a high, virtually constant level, which makes it easily identifiable as a control channel (BCCH). The BCCHs can be suspected in each case as being the source of any continuous impairment. The list view shown in figure 3, arranged in order of maximum field strengths, shows this channel in fifth place. A total of six channels cause field strengths in excess of 100 dB $\mu$ V/m.

**Figure 2: Multi-Channel Power measurement in the GSM 1800 downlink band, bar graph view. Control and traffic channels (BCCH and TCH) are clearly distinguishable by the difference between the RMS and MAX values.**

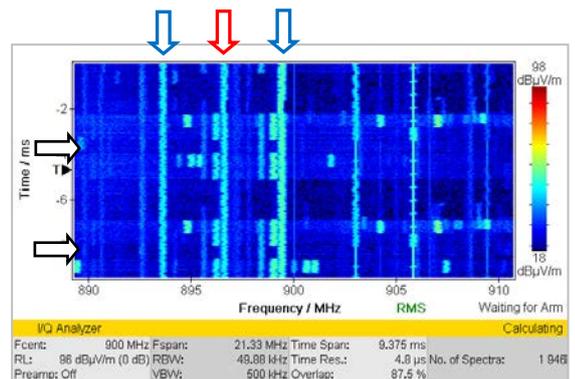
The spectrogram depicted in figure 5 shows some continuous signals in the GSM 900 uplink band that are of approximately equal strength, which are normally not present in the uplink direction (blue / red arrows). The frequencies match the intermodulation table. The typical horizontal bars of uncontrolled frequency conversion are also visible (black arrows). These frequency conversion products only occur, of course, when both the TX channels causing them are "on air".

*Figure 5: Spectrogram. Section of the GSM 900 uplink band. The strong constant signals are atypical for the uplink direction.*

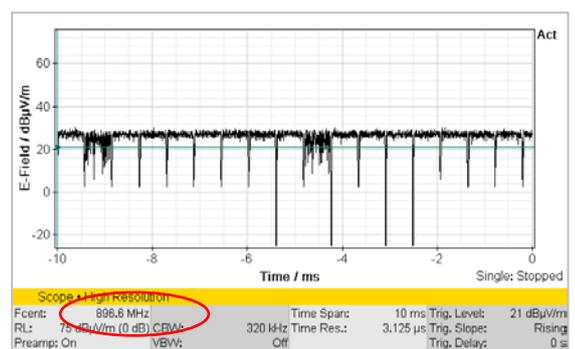
The time domain measurement shown in figure 6 confirms the GSM structure. The duration and repetition of the timeslots is within the GSM standard: In each case, seven timeslots are occupied by telephony (GMSK modulation, constant level), and the eighth timeslot is used for EDGE (8PSK modulation, variable level). Typical for a BCCH: All timeslots are continuously occupied and have the same maximum level. A BCCH in the GSM downlink is thus proven to be the source of interference.

*Figure 6: The time characteristic of the signal at 896.6 MHz shows the typical structure of a GSM downlink BCCH with its timeslots. All slots are occupied; one is filled with a dithering EDGE signal.*

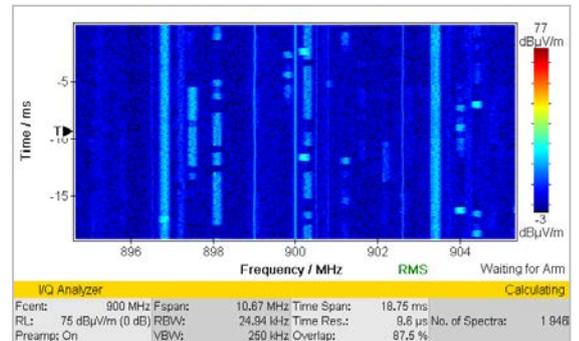
**Figure 7: Example of a spectrogram with (artificially generated) intermodulation.**

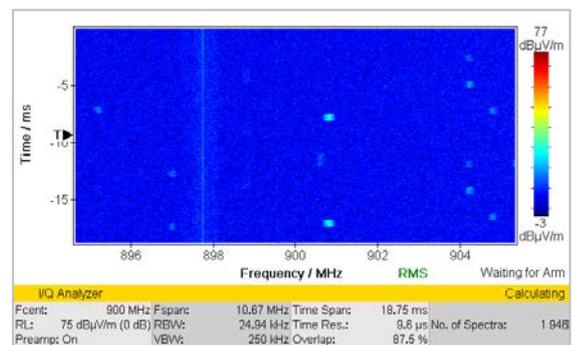
**Figure 8: As above but without intermodulation.**
