Interference measurement and localization at major events

7th World Meeting of Families with Pope Benedict XVI as an example of how the IDA-3106 can be used

This Application Note describes typical interference problems, their analysis and their localization, using this major event as an example.

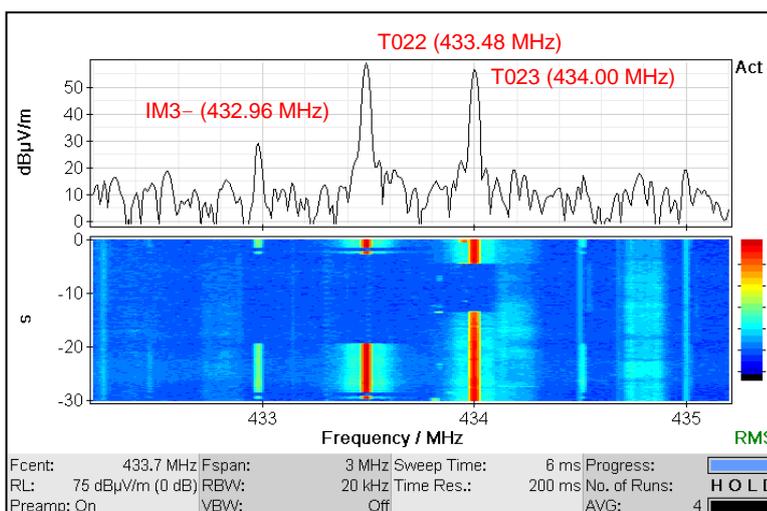
Figure 5: Spectrum and spectrogram of the 433 MHz band showing the two strong emitters in channels T022 and T023 along with the intermodulation product IM3-

The ARI (Associazione Radioamatori Italiani) uses 432,95 MHz for communications. Time and again, this channel is impaired by a neighboring channel, which is not easy to identify. With IDA-3106 MAX trace we found the intermittent interferer in spectrum at 432.96 MHz (figure 5).

Analysis of the spectrum and an understanding of how 3rd order intermodulation occurs leads to two radio services that both only transmit for a maximum of 20 seconds at a time in accordance with the constraints imposed by radio discipline. The spectrogram clearly shows the time correlation between the interferer (432.96 MHz) and the two services on channels T022 (433.48 MHz) and T023 (434.00 MHz). Since the interference only occurs briefly at the exact time when both T022 and T023 are transmitting simultaneously, indirect localization of the interference source from the frequencies causing the interference is the easiest course.

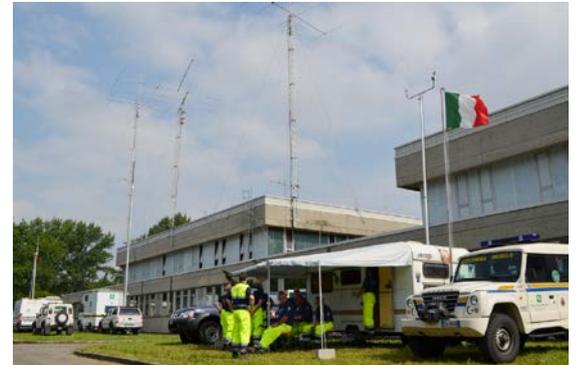
Figure 3: The close proximity of different radio services means that intermodulation can be expected.

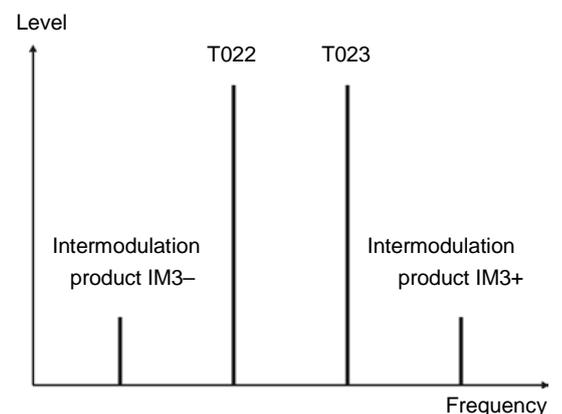
Figure 4: The 3rd order intermodulation products occur principally at the frequencies

$$f_{T023} + (f_{T023} - f_{T022})$$

$$f_{T022} - (f_{T023} - f_{T022})$$

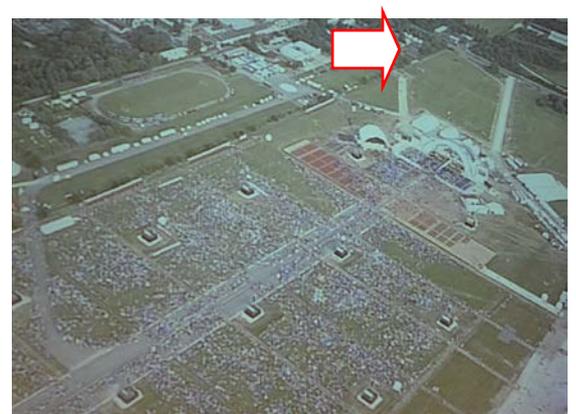
Figure 7: Emitter location on an aerial photograph of the site transmitted to the security services

The cause of the problem is thus identified, so corrective measures can be taken. In this particular situation, only a reduction in the transmitted power will help. Technically, of course, steeper channel cutoff filters would be advantageous. Still, this technical effort can be spared by appropriately instructing personnel and by placing the transmitters further apart to avoid similar interference occurring at future events.
