Interference and Direction Analyzer IDA 2

Technical Note TN102

Clock radio disrupts VHF reception

Interference and Direction Analyzer IDA 2 even nails down small interferers

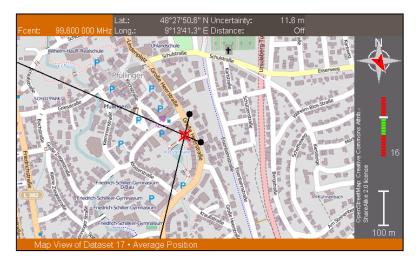
Triangulation indicates the likely location of the interference source.

Triangulation from two Horizontal Scans indicates the apartment block on the opposite side of the street; the area can be narrowed down to just a few houses.

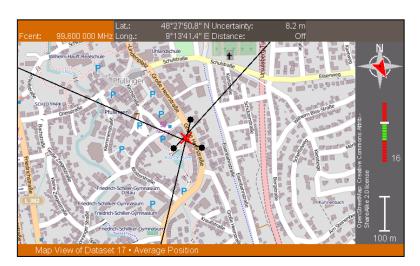
A third bearing taken from behind the building helps to confirm the result.

A further bearing taken from the back of the buildings, together with a direct measurement of the interference signal level close to the buildings serves to confirm the result of triangulation. The highest level at the side of the road is definitely in front of one house, but in front of the next door house when measured at the back of the row of buildings.
